STRUCTURAL EVALUATION
OF THE
BERKELEY SCHOOLS
FOR THE
BERKELEY UNIFIED SCHOOL DISTRICT

FEBRUARY, 1991

BUSD STRUCTURAL EVALUATION

INTRODUCTION

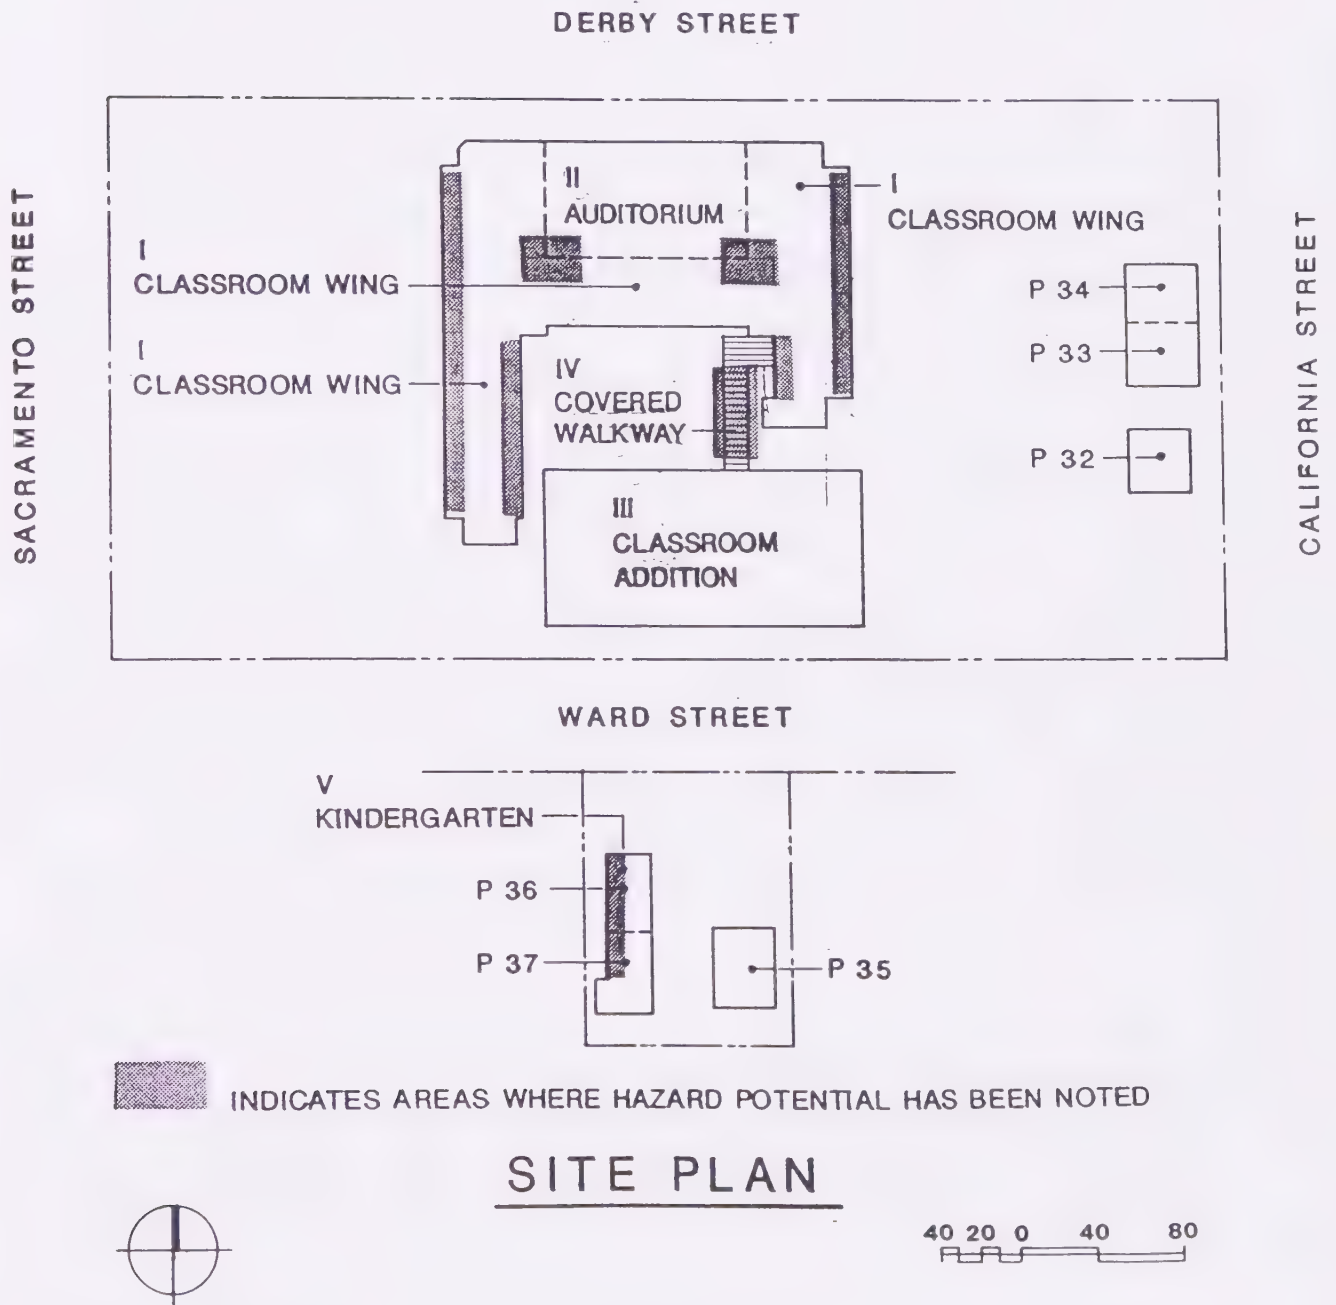
LONGFELLOW

For purposes of evaluation the school has been divided into five elements as indicated on the accompanying sketch. The three classroom wings, designated as Element I, are two stories of wood frame construction above reinforced concrete walls at the basement level. The tall single story auditorium has full height reinforced concrete walls that support a steel truss, wood purlin and joist roof system.
